WSJ Print Edition

Florida Condo's 2021 Collapse Started Three Weeks Earlier

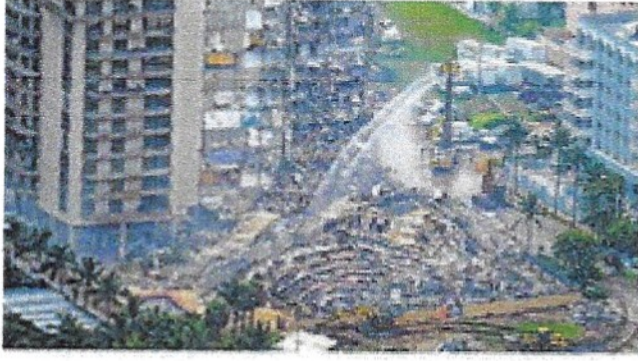
The remains of the Champlain Towers South in Surfside, Fla., in June 2021. The collapse caused the deaths of 98 people. GERALD HERBERT/ ASSOCIATED PRESS

In a report released on Monday, the National Institute of Standards and Technology determined that a structural failure first occurred at two critical garage column connections beneath the pool deck in early June 2021.

Investigators found that when those initial slab-to-column connections failed, the pool deck's concrete slab began to silently warp and fracture over a 21-day period, progressively shifting immense weight to adjacent columns.]
